CONNECTICUT RIVER BASIN  
WHITINGHAM

LAKE SADAWGA  
VT00012

PHASE I INSPECTION REPORT  
NATIONAL DAM INSPECTION PROGRAM

AUGUST 1978

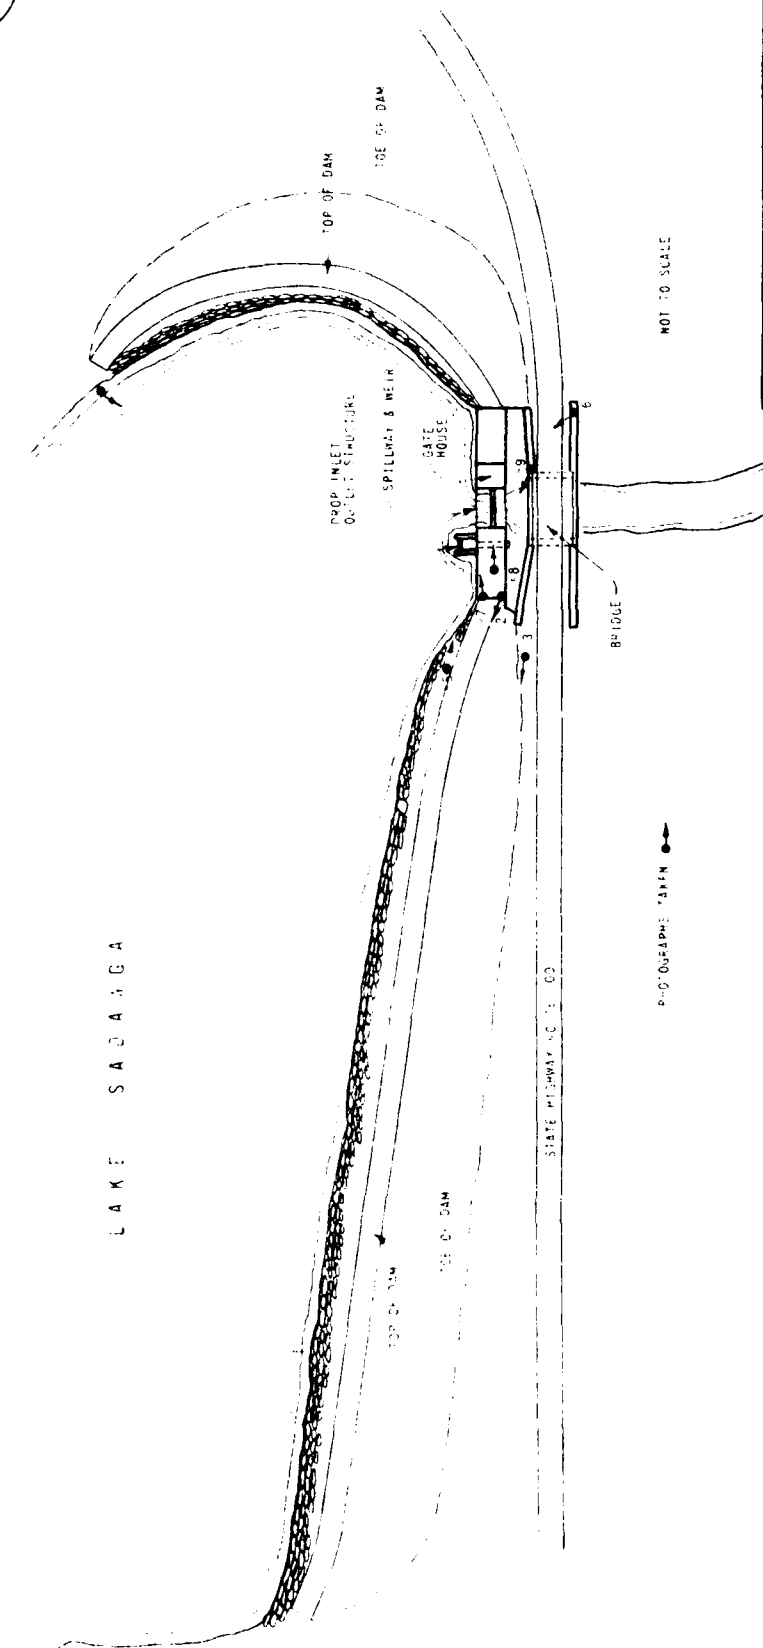
LAKE SADANGA

NOTE: PHOTOGRAPH WAS TAKEN LOOKING WESTERLY ACROSS THE SO-CALLED WEST-DIRE. THE WEST-DIRE IS A WEST-DAM LOCATED AT THE END OF A DIRT ROAD APPROXIMATELY 100 YDS. WEST OF THE MAIN DAM.

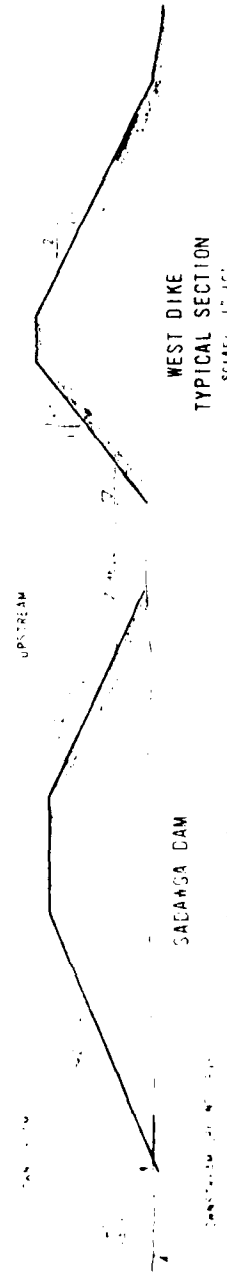
FIGURE 1

Figure 1 shows an approximate cross section, which was taken at a location about 73 feet right of the right spillway training wall. The freeboard is nearly 6 feet and the lake is quite shallow at this location. There is a head of only 2.6 feet across the embankment. The head is several feet high growing from the riprap.
